Service Bulletin

4 - STROKE GS/GSX/GSX-R BULLETIN NO. 192 DATE: 1/15/2009

VOLUNTARY SAFETY RECALL CAMPAIGN #2A08 2005 AND 2006 GSX-R1000 MOTORCYCLES FRAME REINFORCEMENT BRACE INSTALLATION/FRAME REPLACEMENT

UNITS INVOLVED: 2005 AND 2006 GSX-R1000 MOTORCYCLES

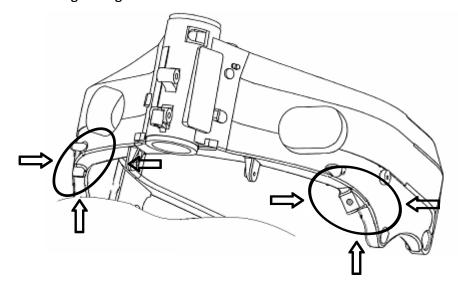
Suzuki has also received reports of cracking or breakage of the frame behind and below the steering neck when the motorcycle is subjected to repeated hard landings from hazardous maneuvers such as extreme or extended wheelies or other stunts. Suzuki believes that this type of driving activity is reckless - and illegal when performed on a public roadway - and does not condone it. If the frame becomes broken during this type of extreme use, a crash could occur.

Dealers will inspect the relevant area of the frame for cracks. The illustration below shows the area to be examined for cracks. If no cracks are found, a frame reinforcement brace will be attached to the frame using bolts and epoxy adhesive. The brace is aluminum and very lightweight (less than 2 pounds). It is very slender and fits underneath the top spar of the frame behind and below the steering neck. The appearance, performance and handling of the motorcycle remain unchanged with the reinforcement brace installed.

Should cracks be found during the inspection, the frame will be replaced with a new frame that has the reinforcement brace installed (see exclusion on page 3).

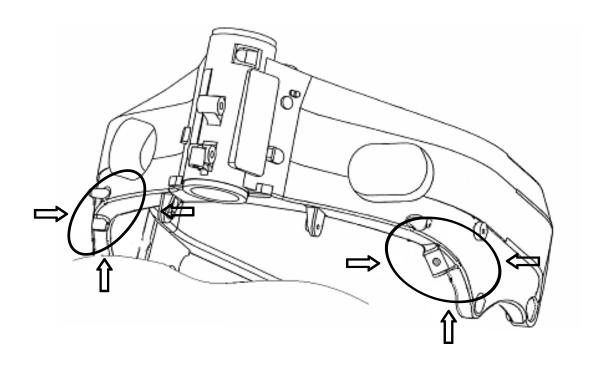
Suzuki has also received reports of cracking or breakage of the frame behind and below the steering neck when the motorcycle is subjected to repeated hard landings from hazardous maneuvers such as extreme or extended wheelies or other stunts. Suzuki believes that this type of driving activity is reckless — and illegal when performed on a public roadway — and does not condone it. If the frame becomes broken during this type of extreme use, a crash could occur.

Your Suzuki dealer will inspect the relevant area of the frame for cracks. The illustration on page 2 shows the area to be examined for cracks. If no cracks are found, a frame reinforcement brace will be attached to the frame using bolts and epoxy adhesive. The brace is aluminum and very lightweight (less than 2 pounds). It is very slender and fits underneath the top spar of the frame behind and below the steering neck. The appearance, performance and handling of your Suzuki remain unchanged with the reinforcement brace installed.

Should cracks be found during the inspection, the frame will be replaced with a new frame that has the reinforcement brace installed (see exclusions at the bottom of this page).
